15 modules from THP 2/2016

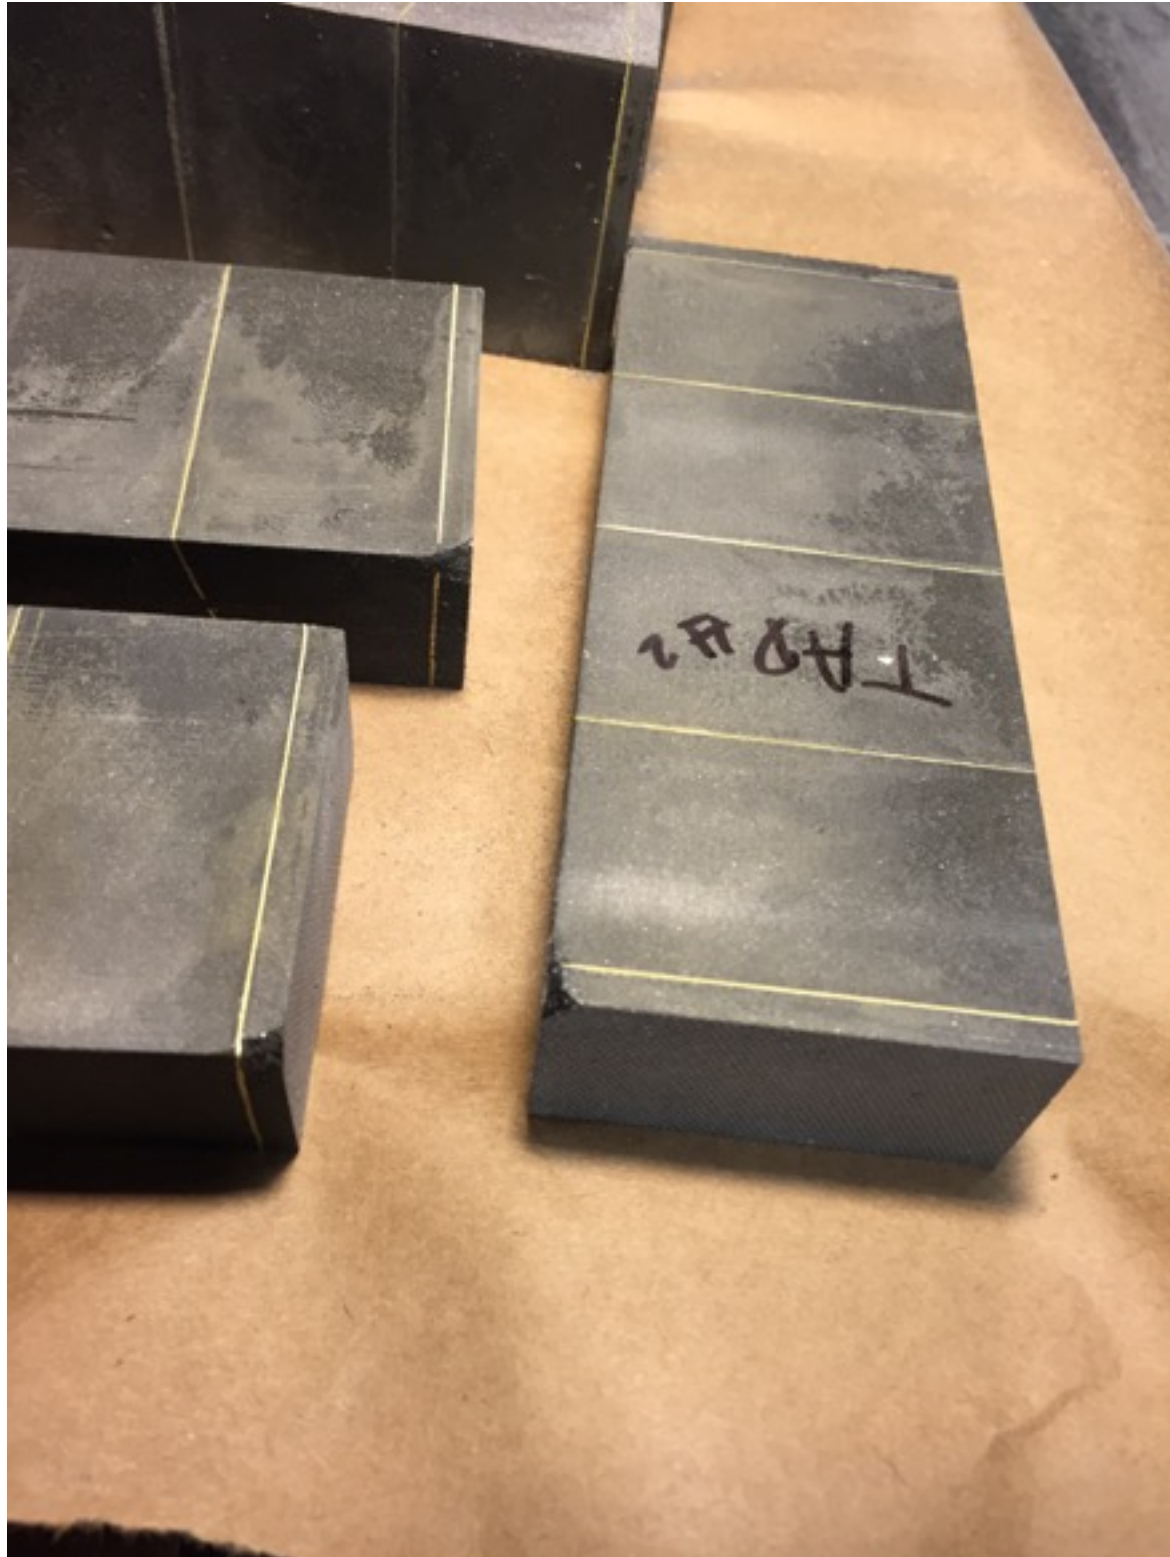
broken corners

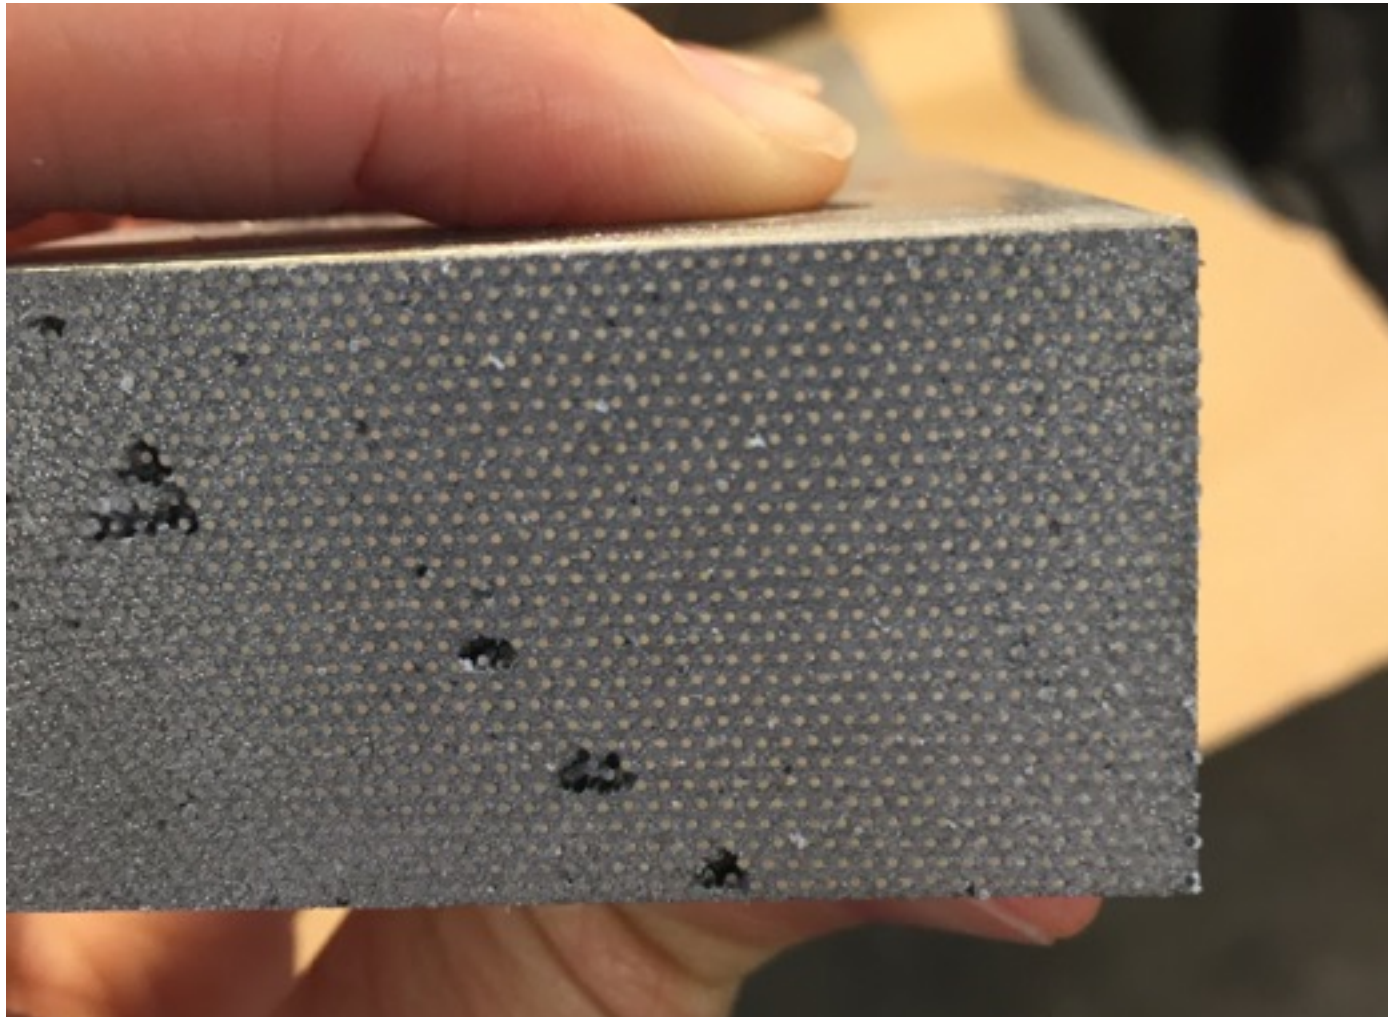
#1, wide end

similar voids on #1, 15, 4 on
wide end
#3, 13 on narrow end

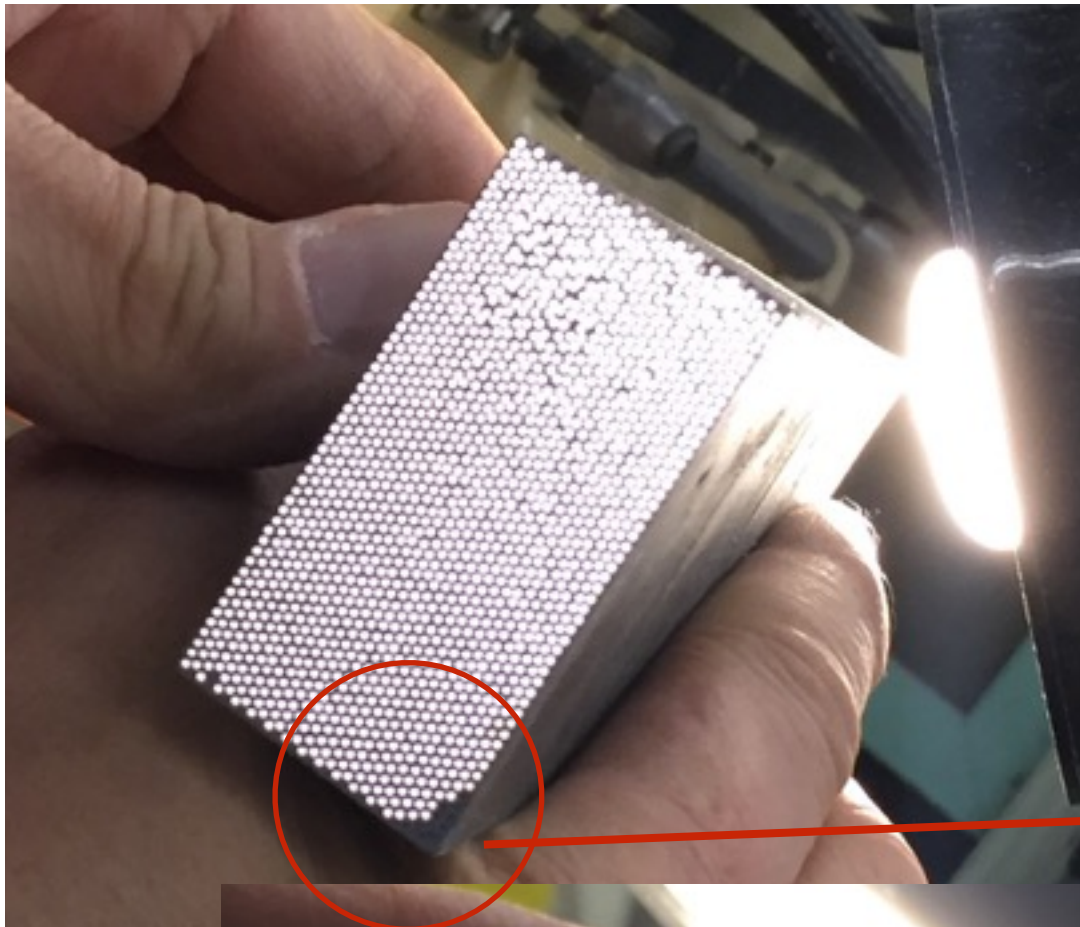
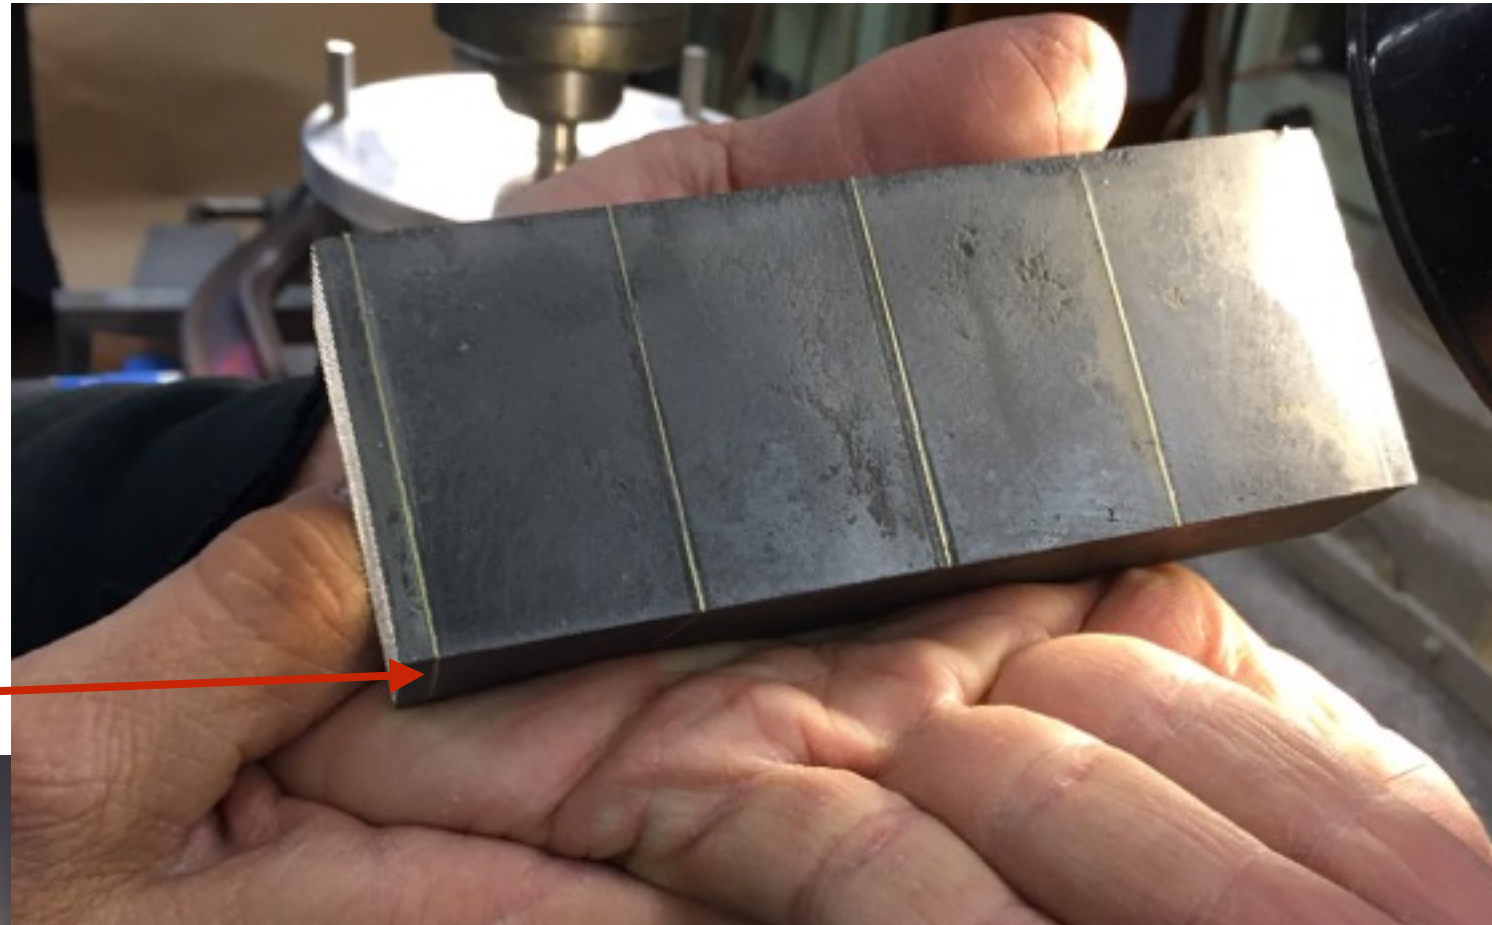
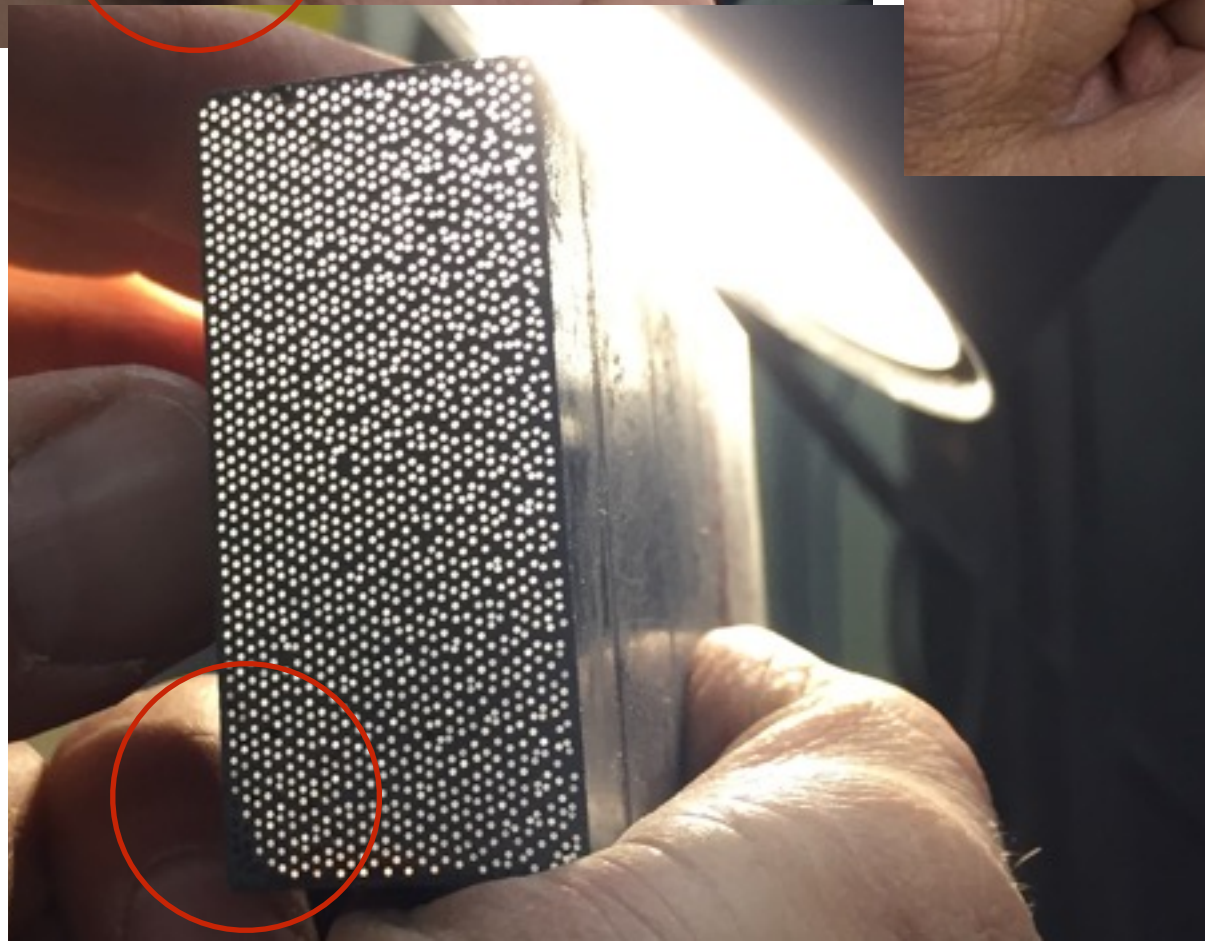
fiber issue module #15

corner fibers exposed
on both ends, no
obvious damage on
outside of module
